## Operation of BigRIPS cryogenic plant

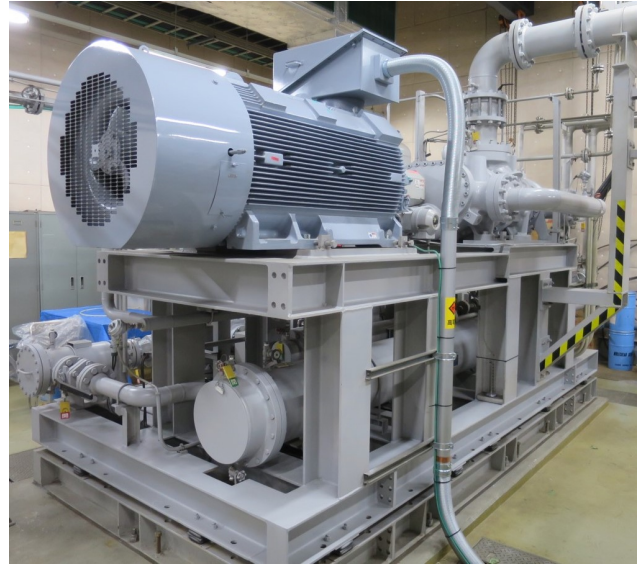
Fig. 2. Compressor unit with the new motor.

We performed two continuous operations of the BigRIPS cryogenic plant in 2022. The first operation period was from February 22 to June 13 and the second was from November 16 to December 28. Between these dates, we replaced the motor unit with a new one (Fig. 2). Figure 3 depicts the vibration accelerations in the vertical and horizontal directions as functions of the total operation time. Three rapid increases in the vibration acceleration at the operation times of 59,000, 71,000, and 78,541 indicate that the damage in the bearing unit occurred in December 2016, June 2019,

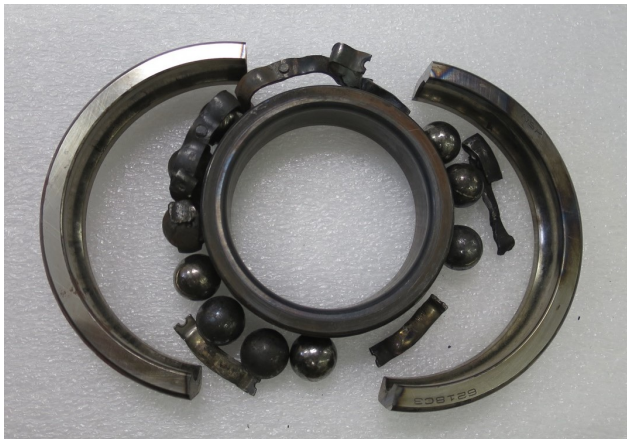
Following the accident that occurred on December 3, 2021,<sup>1)</sup> the main motor of the BigRIPS compressor unit was shipped to the manufacturer’s factory and disassembled. Damages were found in the bearing units on both the coupling and anticoupling sides. In particular the bearing unit on the coupling side was heavily damaged such that the ribbon retainer was destroyed and the surfaces of the bearing balls and rings were ruined (Fig. 1). We also found that the size of the housing for the damaged bearing unit was 20  $\mu\text{m}$  larger than its standard dimension (+0 to 25  $\mu\text{m}$ ). After cleaning the rotor and stator, the motor unit was reassembled using new bearing units and the re-manufactured bracket housing. In addition to mechanical maintenance, the insulation was also examined, and little deterioration of the stator insulation was noticed. We decided to replace the motor unit in the summer maintenance period.

Fig. 1. Damaged bearing unit, disassembled from the coupling side of the motor unit.

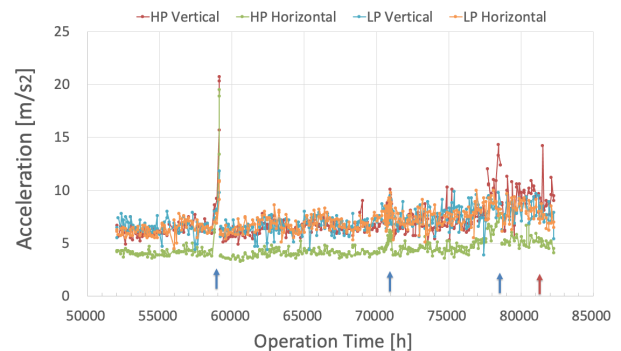
Fig. 3. Vibration acceleration of the compressor unit.

and December 2022.<sup>1)</sup> The red arrow at the operation time of 81,235 hours indicates the replacement of the motor unit. Although the vibration acceleration does not change significantly, the typical operation current of the motor unit decreased from 30.0 to 26.6 A.

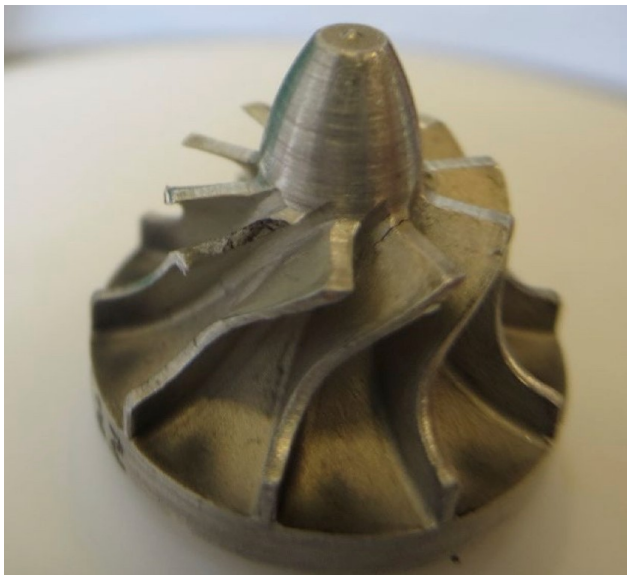
In 2022, another incident occurred: the damage of the first expansion turbine T1 in the refrigerator. We visually inspected T1 and T2 turbines during every summer maintenance. It was found that the blades of the expansion wheel of the T1 turbine were broken (Fig. 4). The T1 cartridge was then sent to its manufacturer, Linde, and disassembled. Linde reports that the fractured surface indicates the typical characteristics of a low-cycle fatigue (LCF). The expan-

Fig. 4. T1 expansion turbine wheel with broken blades.

sion and compressor turbine wheels are replaced with new ones and re-assembled with new axial bearings. Before remounting the T1 cartridge on the refrigerator, we investigated the inside of the refrigerator using a fiberscope. No fragments but tiny metal dust was found in the downstream piping of the T1 expansion turbine. After the dust was removed using a vacuum cleaner, the T1 turbine was mounted on the refrigerator. We switched the refrigerator on for pre-cooling on November 16, and the STQ1-5 cryostats were filled with liquid helium on December 3. Although the average liquefaction rate of  $26 \text{ m}^3/\text{h}$  is the same as before, the rotation speed of 4450 rps of the T1 turbine during the steady-state operation was lower than its design value of 4600 rps. The origin of the LFC and the lower rotation speed of the T1 turbine are currently under investigation.
